The REMR Bulletin

VOL 6, NO. 2

In Situ Repair of Deteriorated Concrete

Rehabilitation of Crow Dam Gate Tower

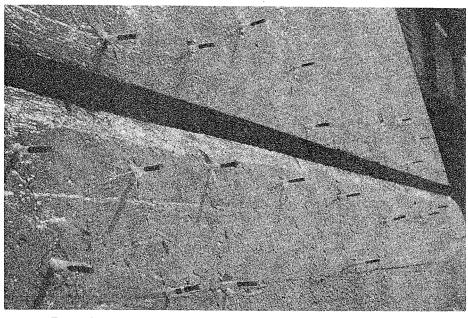
Ports in gate pier for pressure injection repair, Dam 13, Mississippi River

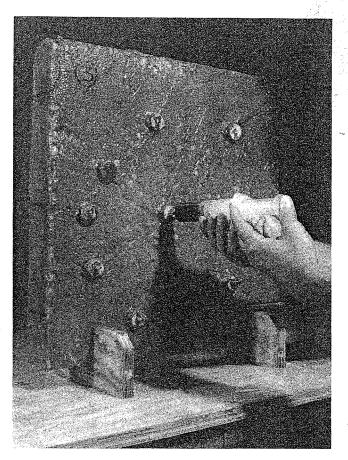
Figure 1. Laboratory injection of cracked concrete slab

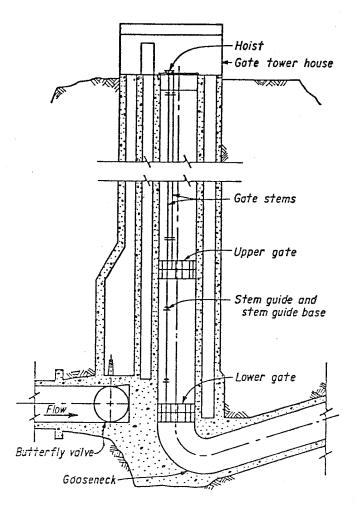
Figure 1. Gate tower

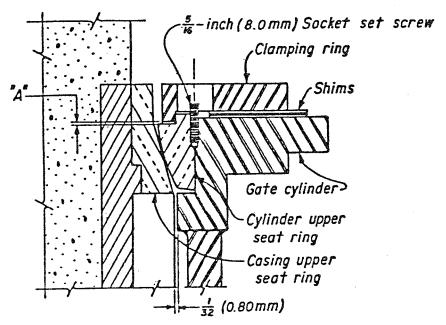
To obtain the field adjustment of the upperseat ring, five 1-in.-diam holes were drilled in each of the three clamping rings, between the existing holes, to coincide with the inside face of the cylinder upper seat ring and the gate cylinder. During installation of the gates, the lower gate, with its cylinder bottom seat ring installed, was lowered down the tower so that the gate seated on the bottom casing seat ring. The cylinder upper seat ring was then placed in position, and the clamping rings were installed with shims located between the clamping rings and the top of the gate to maintain a maximum gap of 0.020 in. at location "A" in Figure 2.

Figure 2. Upper seating adjustment

Holes were drilled and tapped for socket set screws at the locations of the 1-in. holes in the clamping rings. The shims were then adjusted so that the clamping ring firmly held the seat ring. This procedure ensured that if the lower seat rings were to lose contact after a period of time, the gate weight would not be solely on the set screws.

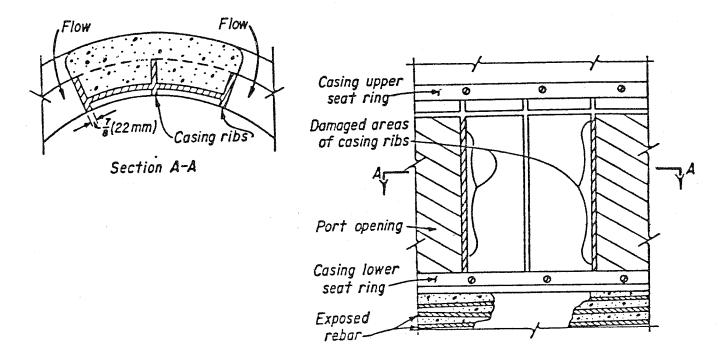
Both upper- and lower-gate casings had damage on the inside surfaces of the vertical ribs (Figure 3). The casing ribs adjacent to the port openings had suffered from erosion, and the fluctuating

Figure 3. Gate casing damage

radial movement of the gate at different openings had caused the casing ribs to break away. Because the gate casing is embedded in concrete, the cost of replacing it would have been extremely high. Also, because the casing is made of cast iron, repairing it with conventional welding techniques would have been difficult. However, molecular welding, a modern technology that uses proprietary materials to build up damaged metallic areas, can be used to repair the type of casing damage found at Crow Dam. A base and solidifier mixed together to form a compound that has nonslump, nonshrink characteristics and a short curing time is ideal for field applications in which access and working conditions are confining and awkward. Once cured, the material has the mechanical properties of a low carbon steel and can be machined or ground for final sizing.

Steps involved in the repair included: brushing away any loose contaminates, grit-blasting with copper slag, mixing and applying Belzona Molecular Ceramic R-Metal,* curing for 2 hours, measuring and reapplying the repair material until the build-up was satisfactory, and finally brush coating with 10 to 15 thousandths of Belzona Molecular Ceramic S-Metal* to give added protection against erosion and corrosion.
